Investigation of the Performance of the New Orleans Flood Protection Systems in Hurricane Katrina on August 29, 2005

Volume I: Main Text and Executive Summary

**Final Report
July 31, 2006**

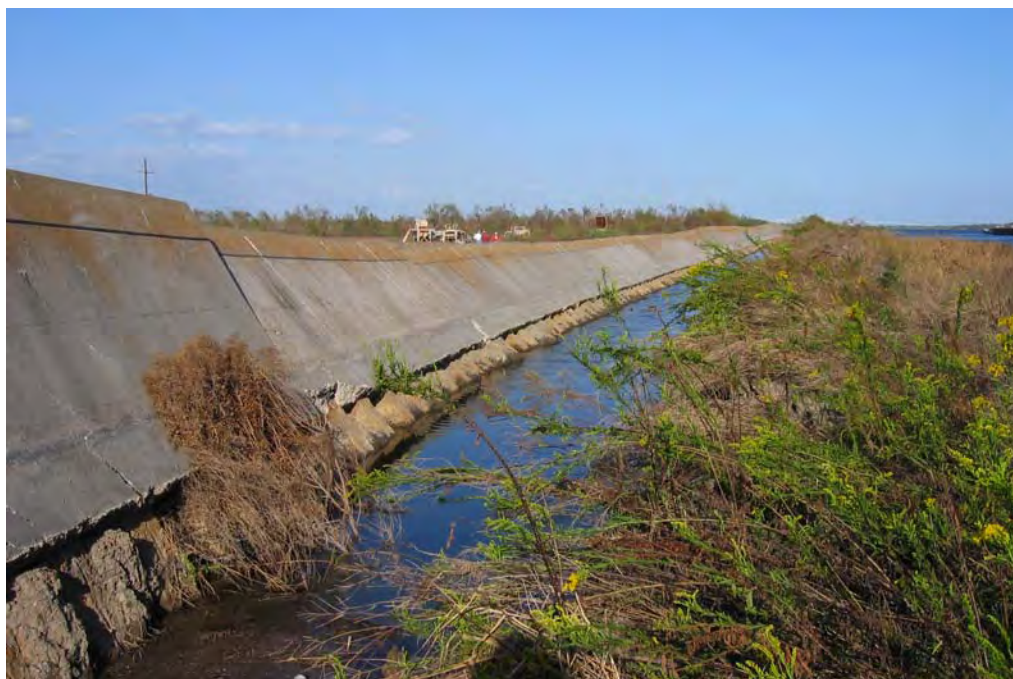
Figure 7.14: Significant lateral deflection of the Citrus Back Levee floodwall, seen from the inboard (protected) side. Note the heave adjacent to the displaced sheetpiles and wall.

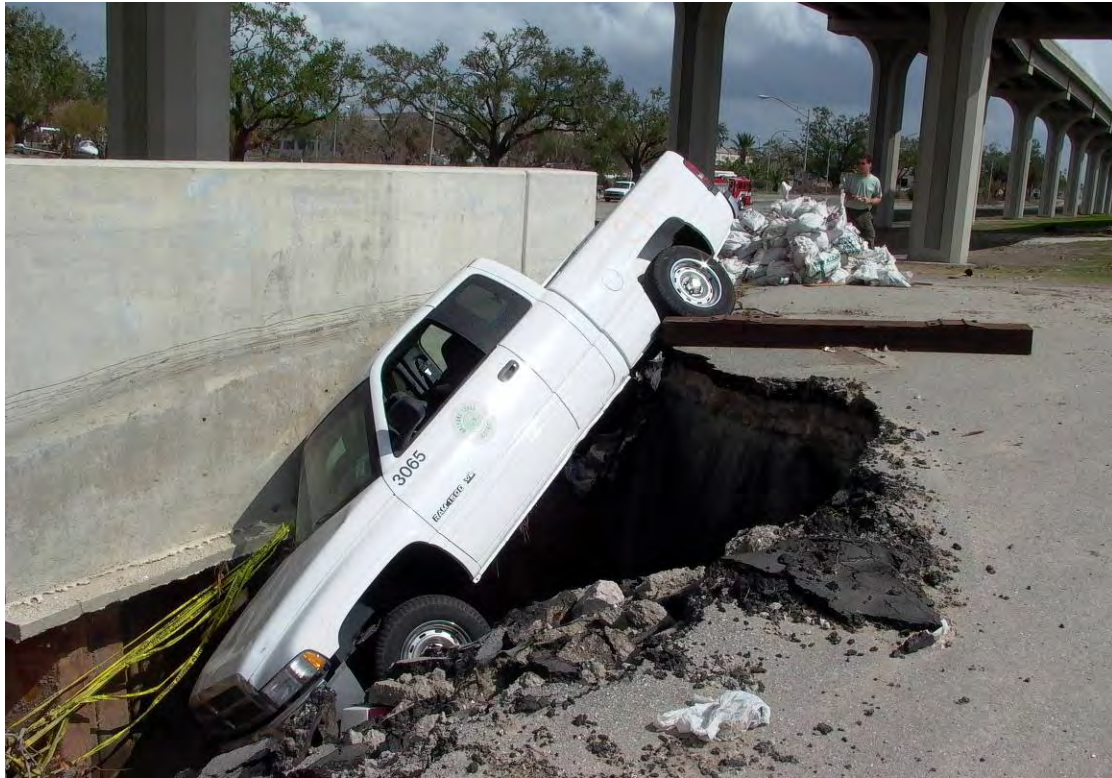
Figure 7.20: One of numerous examples of partially exploited erosive vulnerability at a “transition” section along the IHNC levee frontage; in this case a transition from a gated concrete floodwall to a full height earthen levee section.

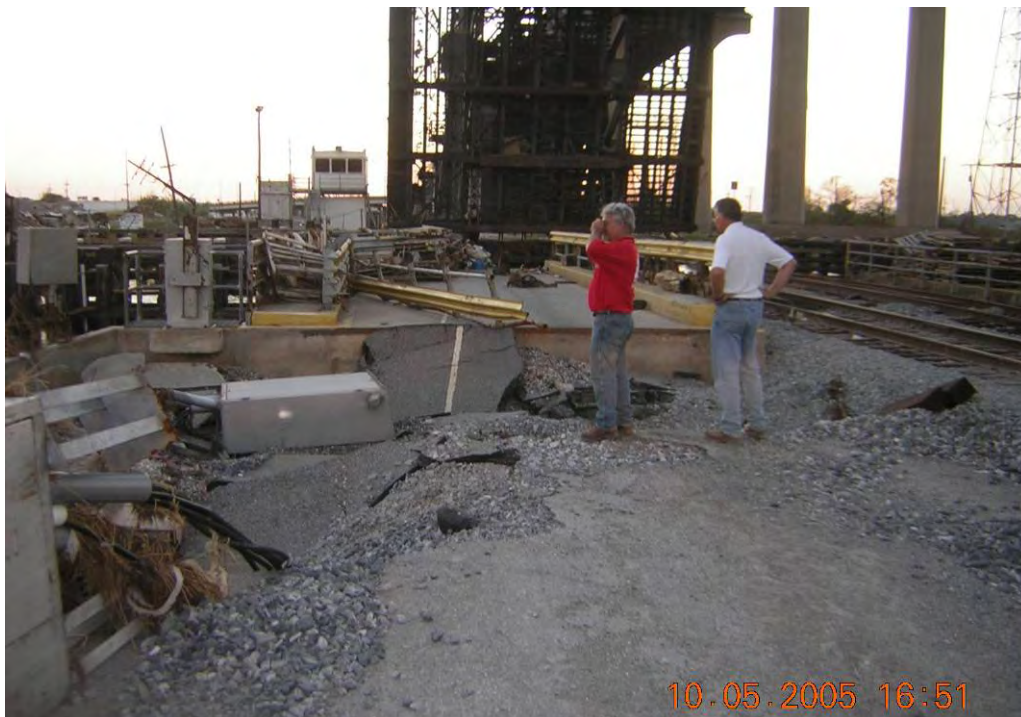
Figure 7.21: Another example of partially exploited erosive vulnerability at a “transition” section along the IHNC levee frontage; in this case a transition from a roadway floodgate to a full height earthen levee section.

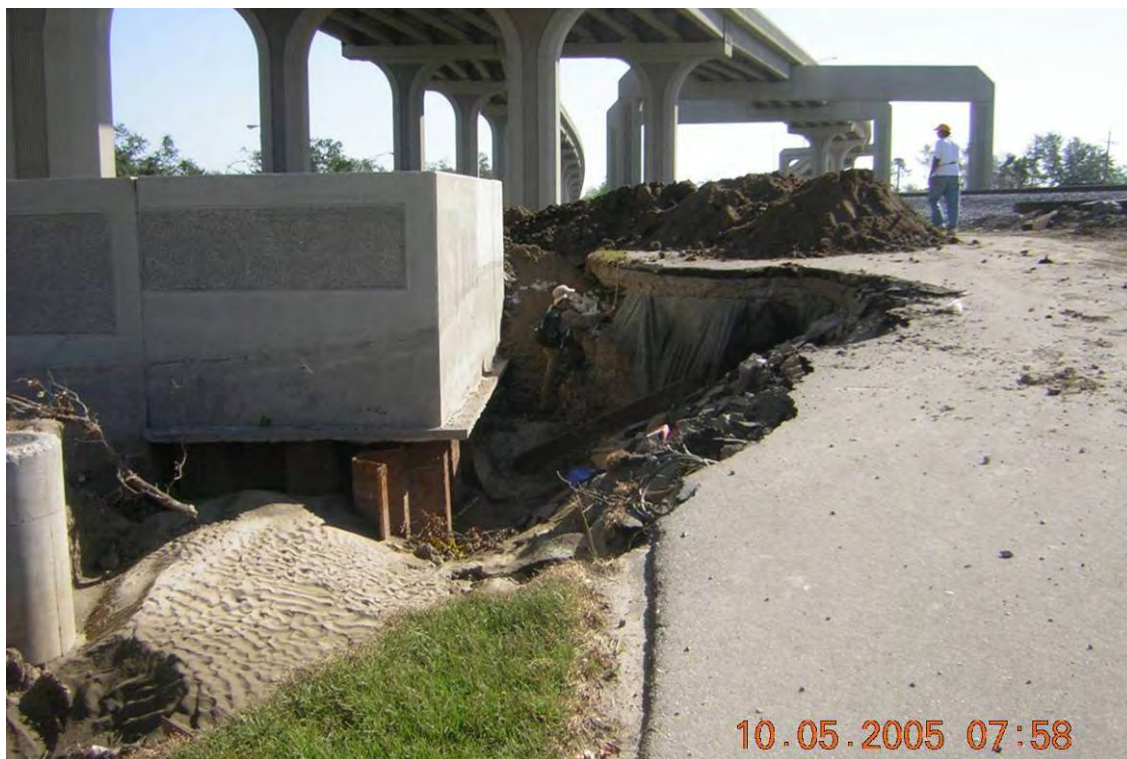
Figure 7.23: Storm-surge induced overtopping traveled through the granular gravel ballast for the railroad line and eroded the railroad line embankment, which served as a transition levee between the concrete floodwall and the earthen levee shown in Figure 7.25. [Base image from Google Earth, 2006]

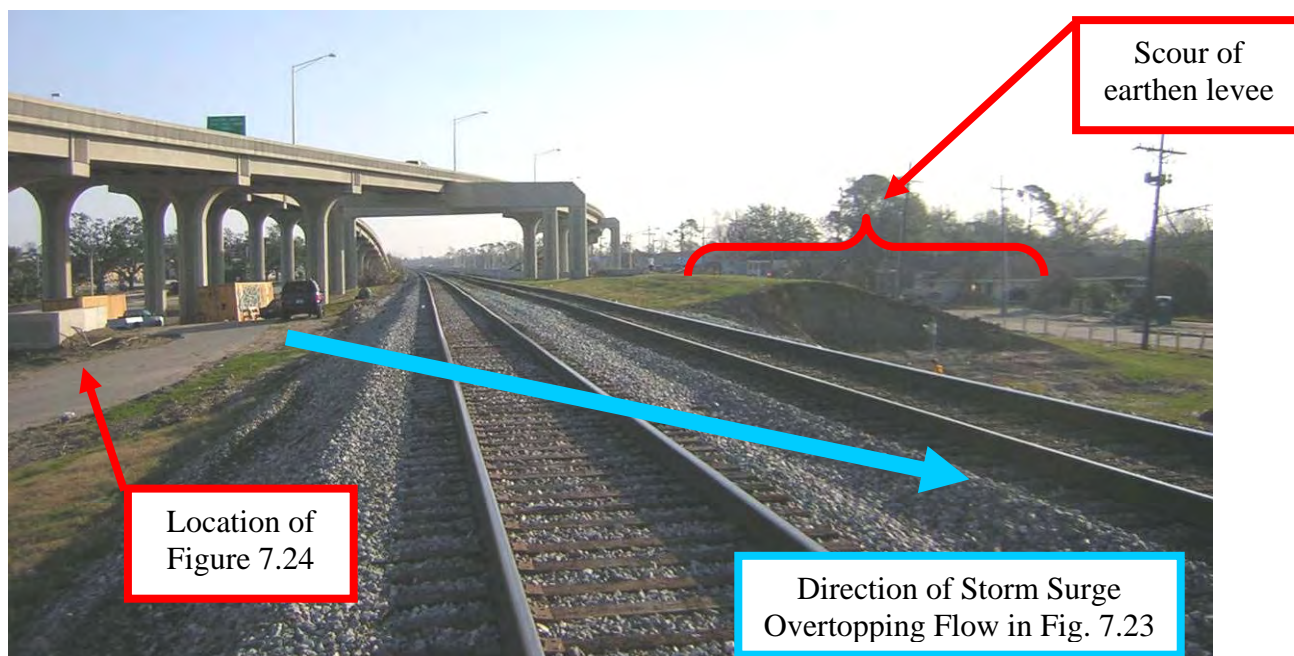
Figure 7.24: IHNC levee near the Lakefront Airport adjacent to the railroad section from Figure 7.23, showing erosional failure and scour at transition to concrete floodwall protecting highway support.

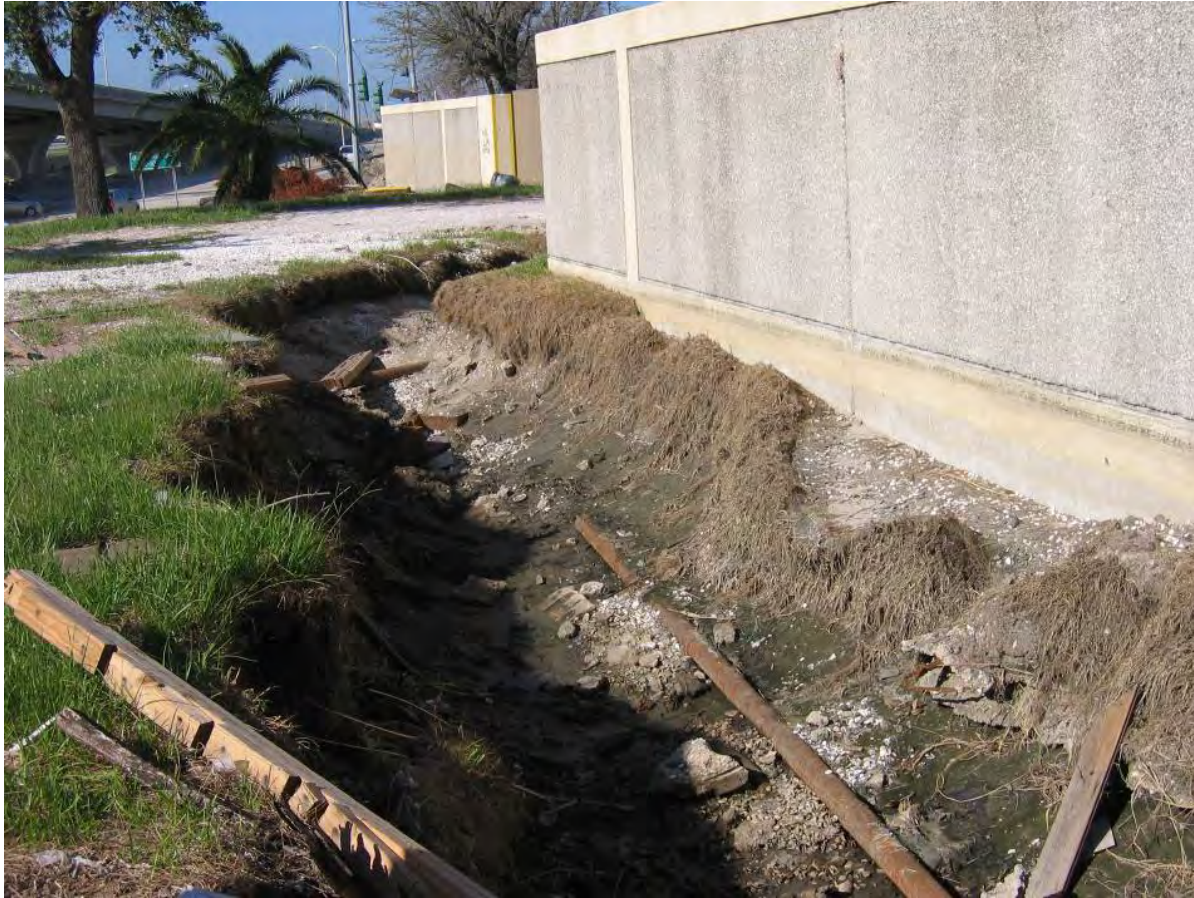
Figure 7.25: Significant erosion was observed on the levee adjacent to (and behind) the floodwall shown in Figure 7.24. The storm surge overtopped the floodwall and railroad ballast and failed the earthen levee behind the railroad.

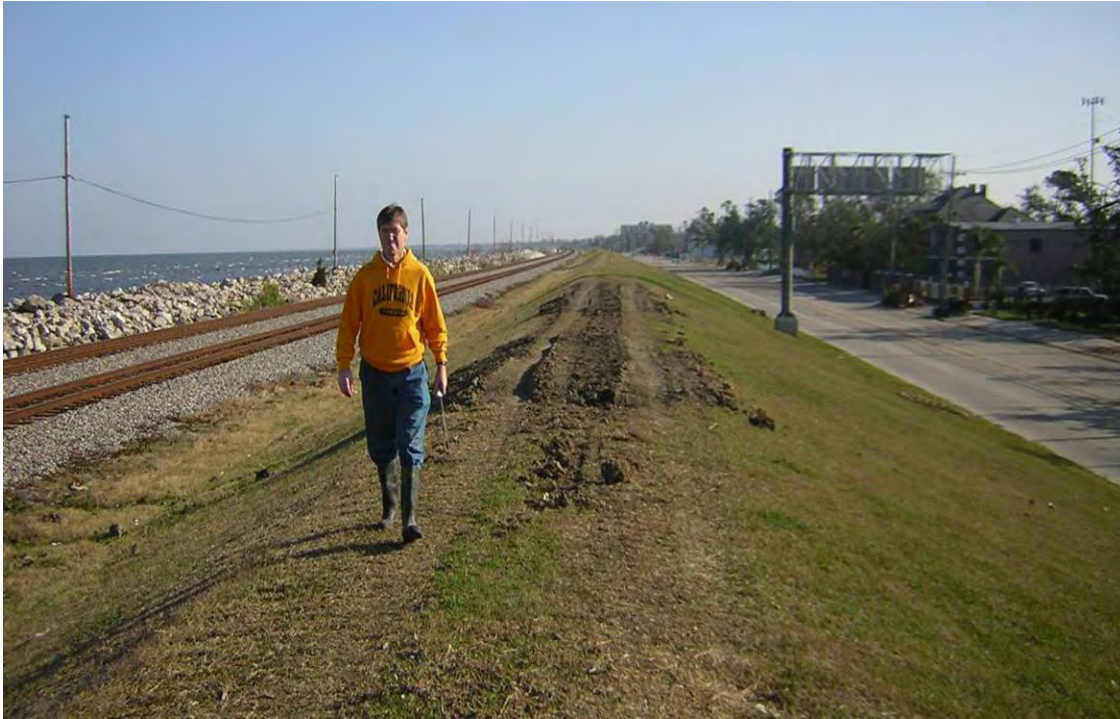
Figure 7.26: Scour near the base of a floodwall near the Lakefront Airport.

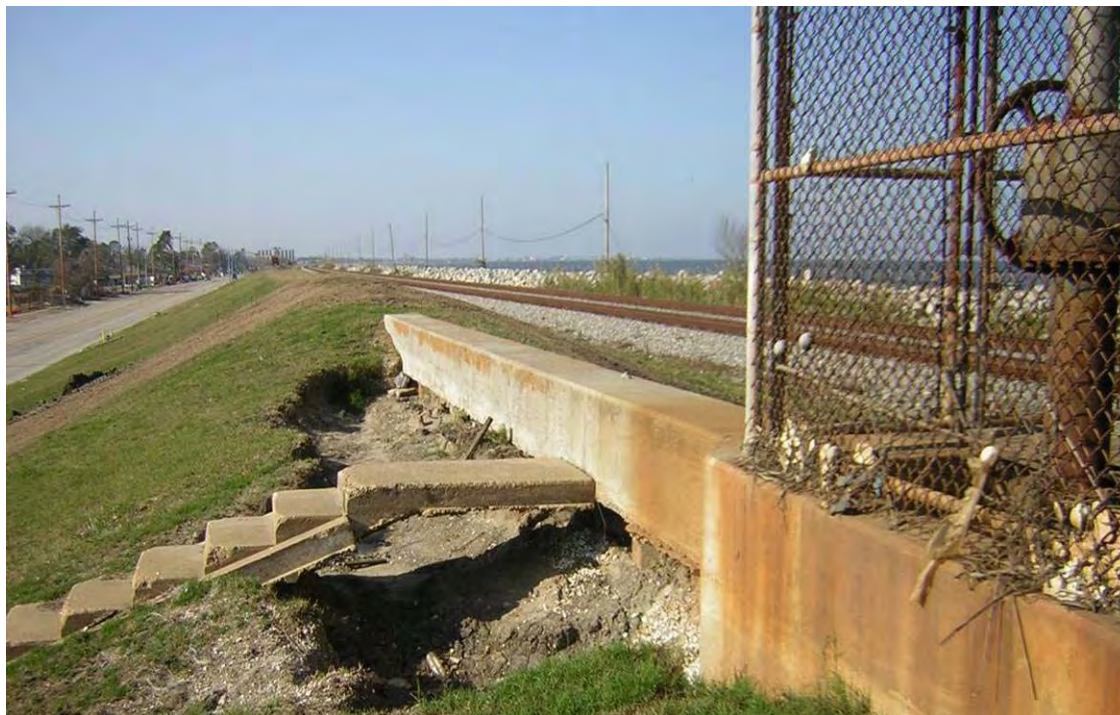
Figure 7.27: Lakefront levee near the Jahncke Pump Station outfall structure, where minor overtopping erosion occurred. These levees performed well and only minor, surficial damage was observed.

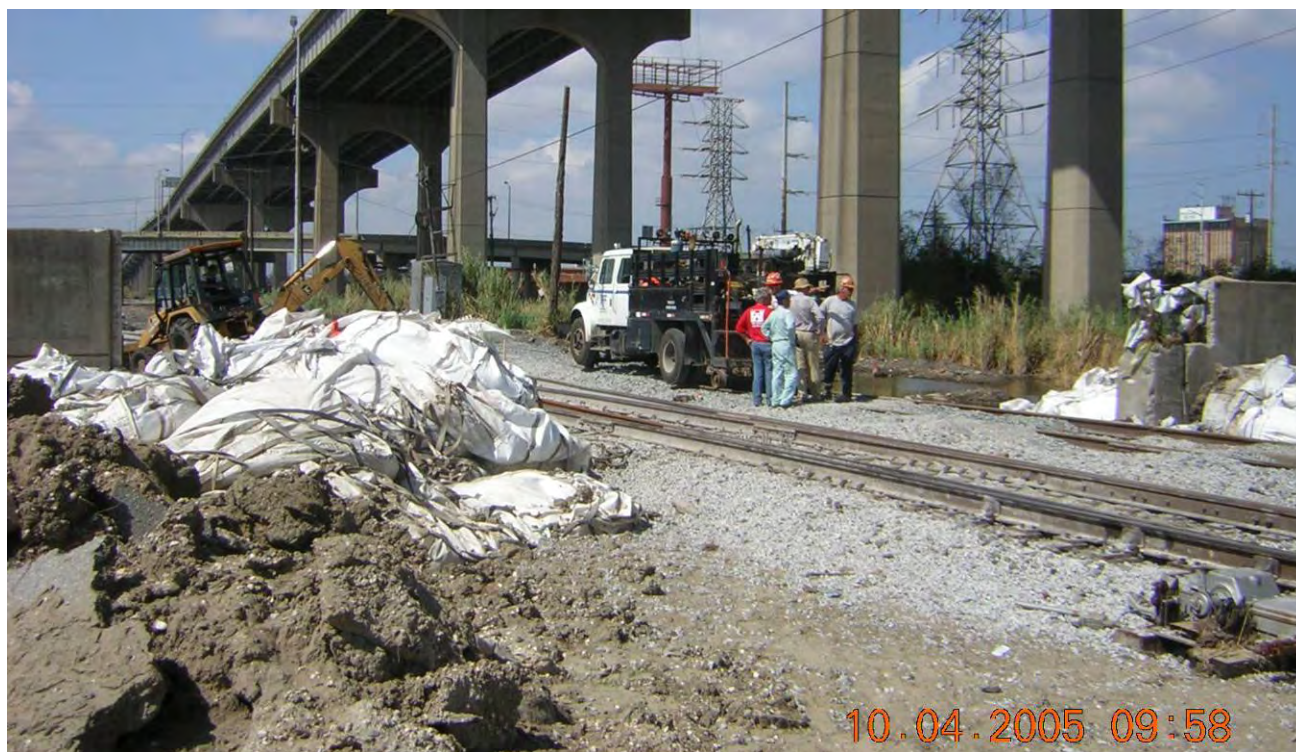
A third candidate breach site is the west bank of the IHNC at the CSX railroad crossing, as described in Section 8.2.2. At this location, a steel “storm gate” on rollers had been damaged by a train accident several months prior to Hurricane Katrina, and was away for repair. In lieu of this missing gate, a sandbag levee crest section had been constructed in the opening left by the missing floodgate. The sandbags washed out at some point during Katrina, and this may have been the early breach reflected by the gage readings shown in Figure 8.3. At this same site, flow along the juncture between the railroad embankment and the adjacent embankment fill supporting an asphalt paved roadway passing over the earthen Federal levee resulted in erosion and scour that produced a second breach feature at essentially this same site, as is also described in Section 8.2.2.

Figure 8.4 shows the concrete structural floodwall on the west side of the IHNC, at the east edge of the Orleans East Bank (Downtown) protected area. Note that there is no steel gate shown in this photograph. The steel gate at this location had been damaged by a train accident several months prior to Katrina’s arrival, and it was away for repair at the time of the hurricane.

In lieu of this missing steel gate, a temporary sandbag “levee” was erected across the opening. At some point during the storm this sandbag “levee” section either was pushed over by the rising storm surge or was overtopped and washed away.

Figure 8.4: Concrete storm gate at the west bank of the CSX Railroad crossing of the IHNC, after Hurricane Katrina, showing the steel floodgate missing.

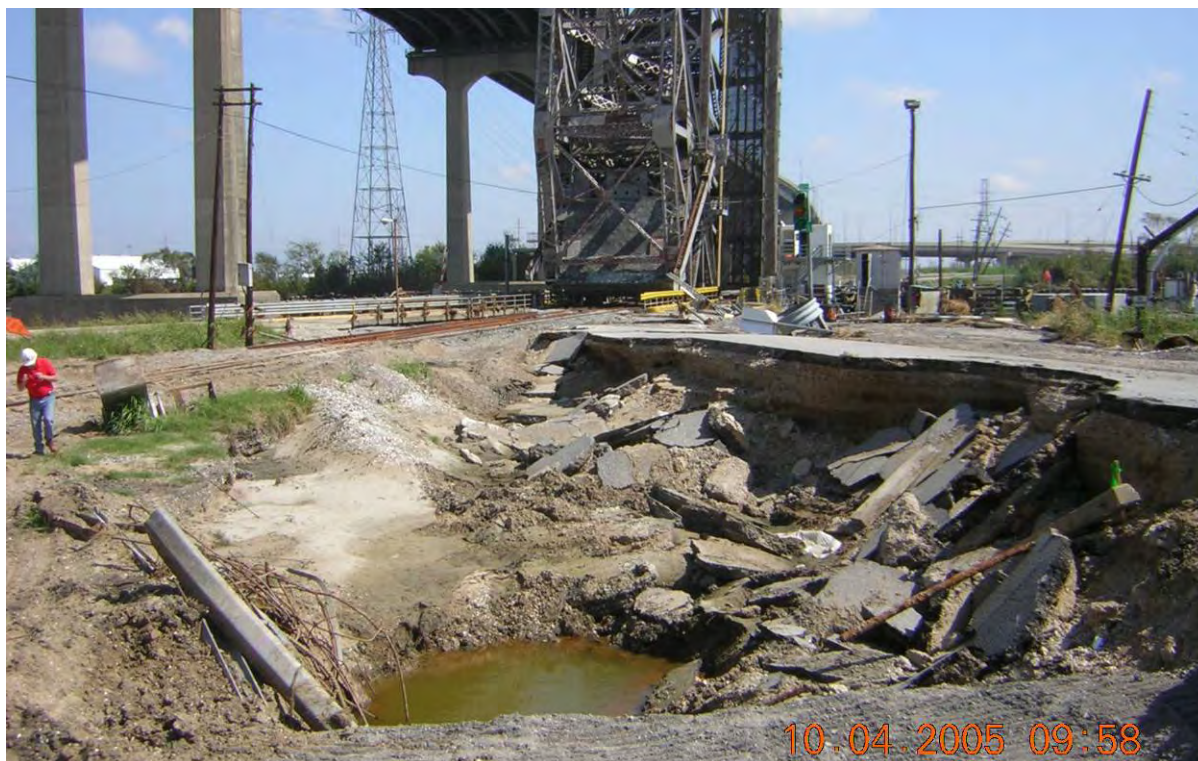
Figure 8.5: View from the inboard side of the CSX Railroad breach site from Figure 8.4 showing scour of the roadway fill adjacent to the railway embankment fill.

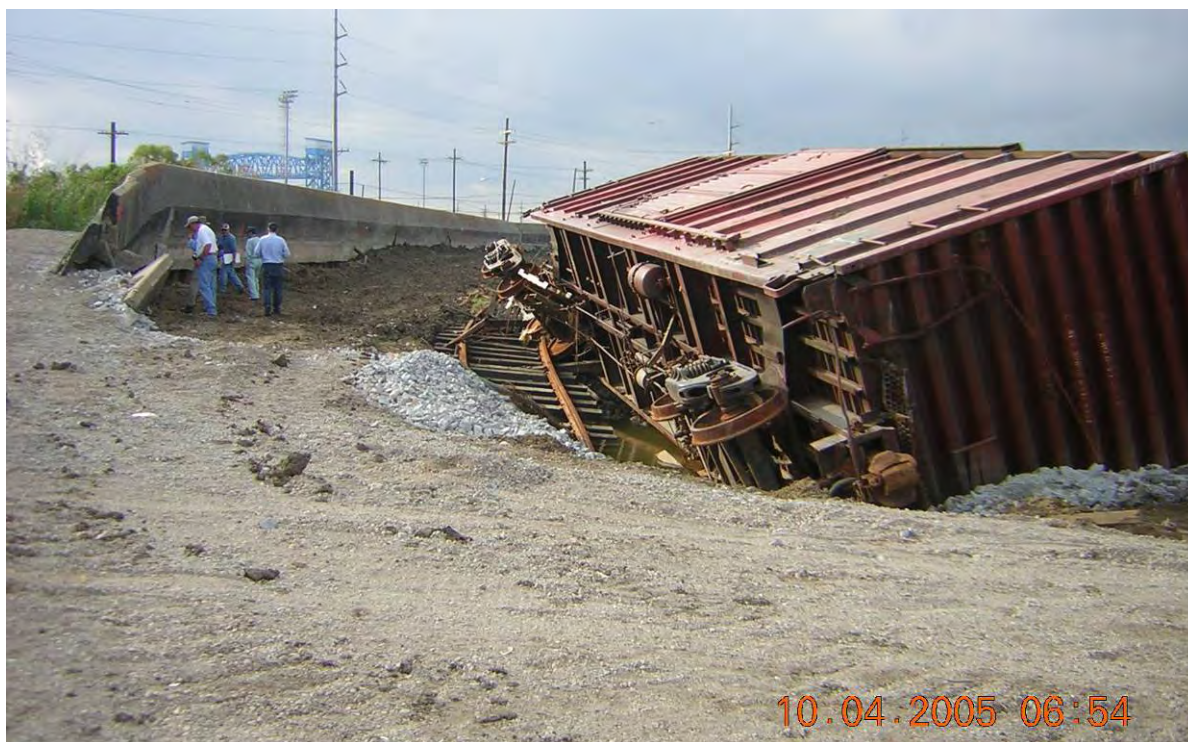
A significant breach occurred on the west side, behind the main Port of New Orleans, due to overtopping and erosion of soil support for an I-wall (see Section 8.2.3.1.). The elevation of the I-wall, and the observed overtopping erosion, indicate that this failure occurred later in the morning as well when the storm surge had risen high enough to pass water over the top of this floodwall (see Section 8.2.3.1.).

Figure 8.6: The I-wall section breach behind the Port of New Orleans, showing floodwall failure.

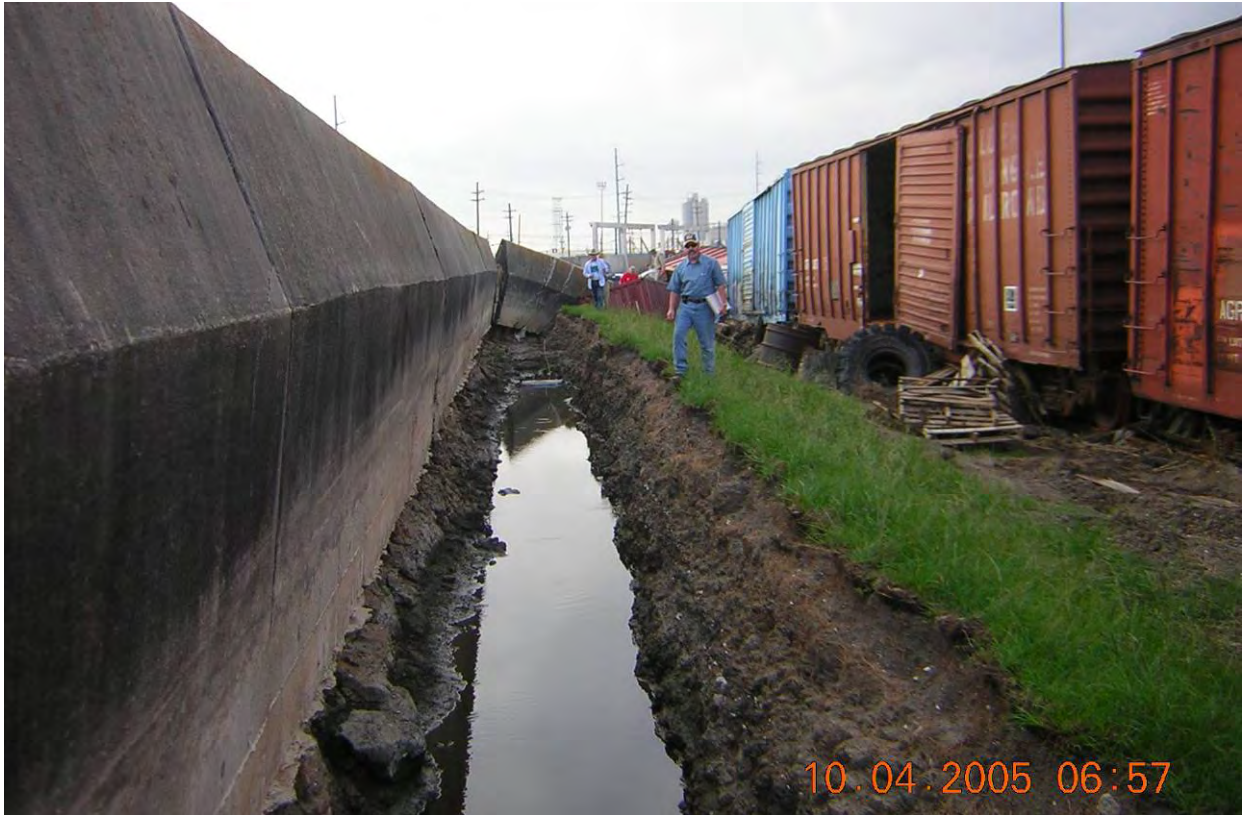
Figure 8.7: Second view of the I-wall failure at the Port of New Orleans showing the trench scoured by overtopping flows.

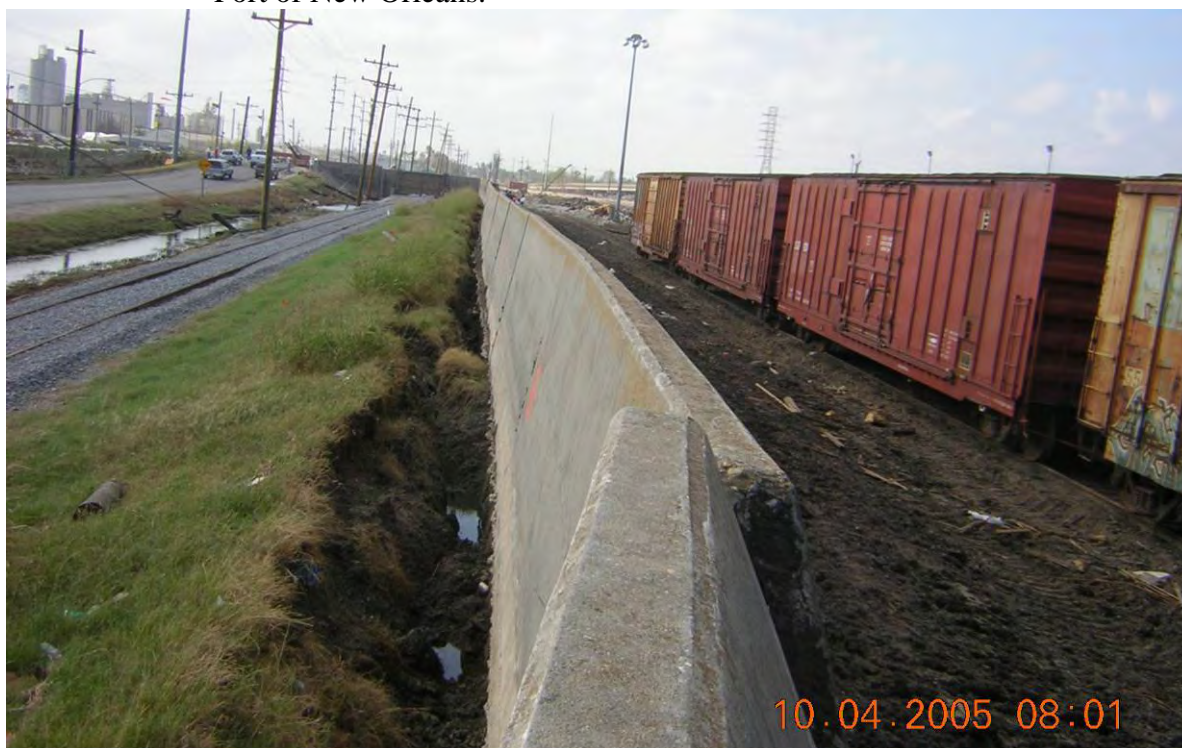
Figure 8.12: Erosion, gapping and offset of adjacent wall sections at the east end “transition” of the concrete floodwall and gate structure from Figure 8.11.

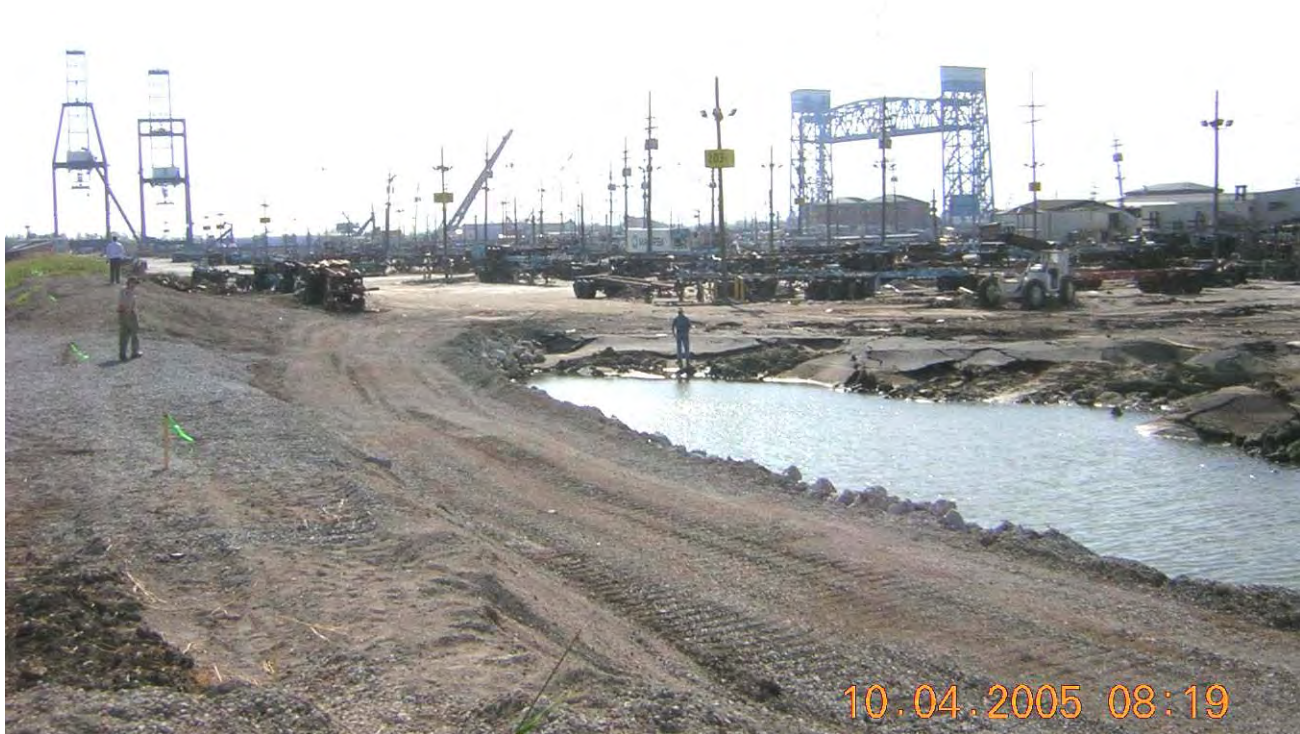
Figure 8.14: Close-up view of the highly erodeable shell sand fill at the breach shown above in Figure 8.12.

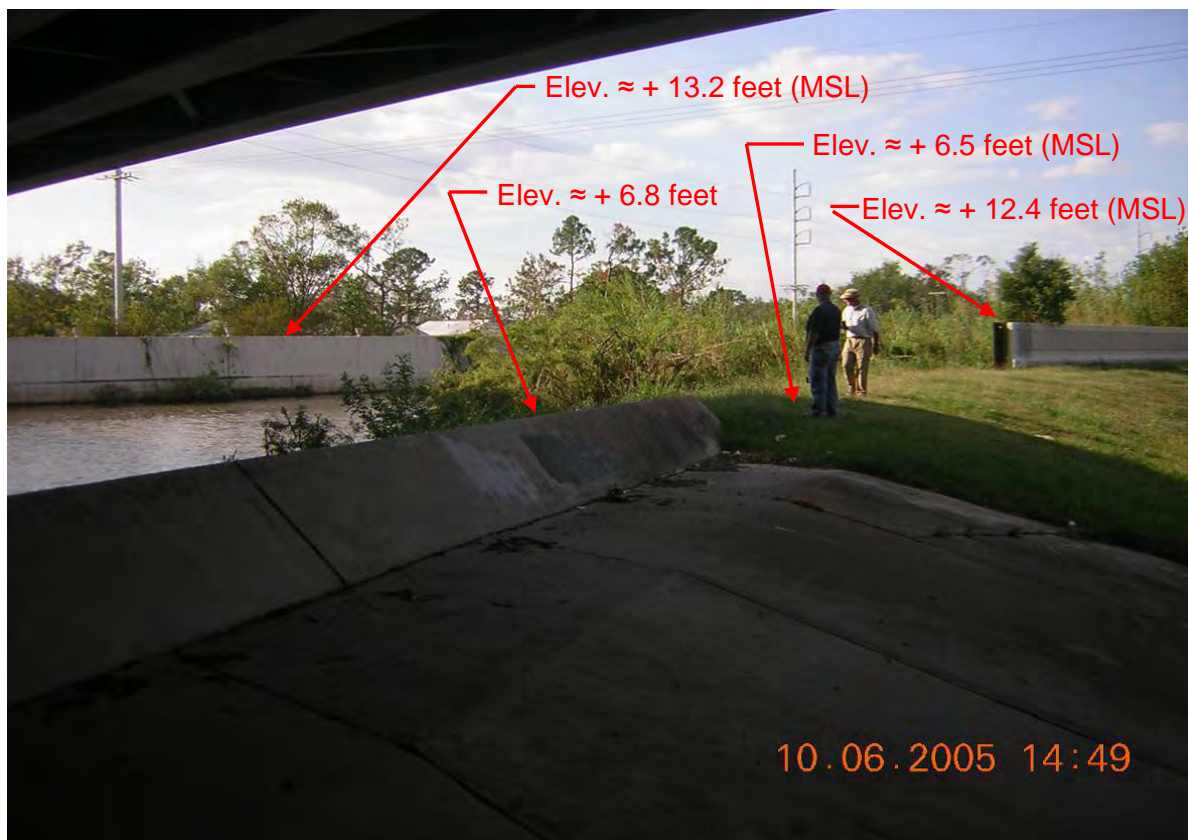
Figure 8.19: View of the pump house, levees and floodwalls, and the "gap" at the south end of the Orleans canal.

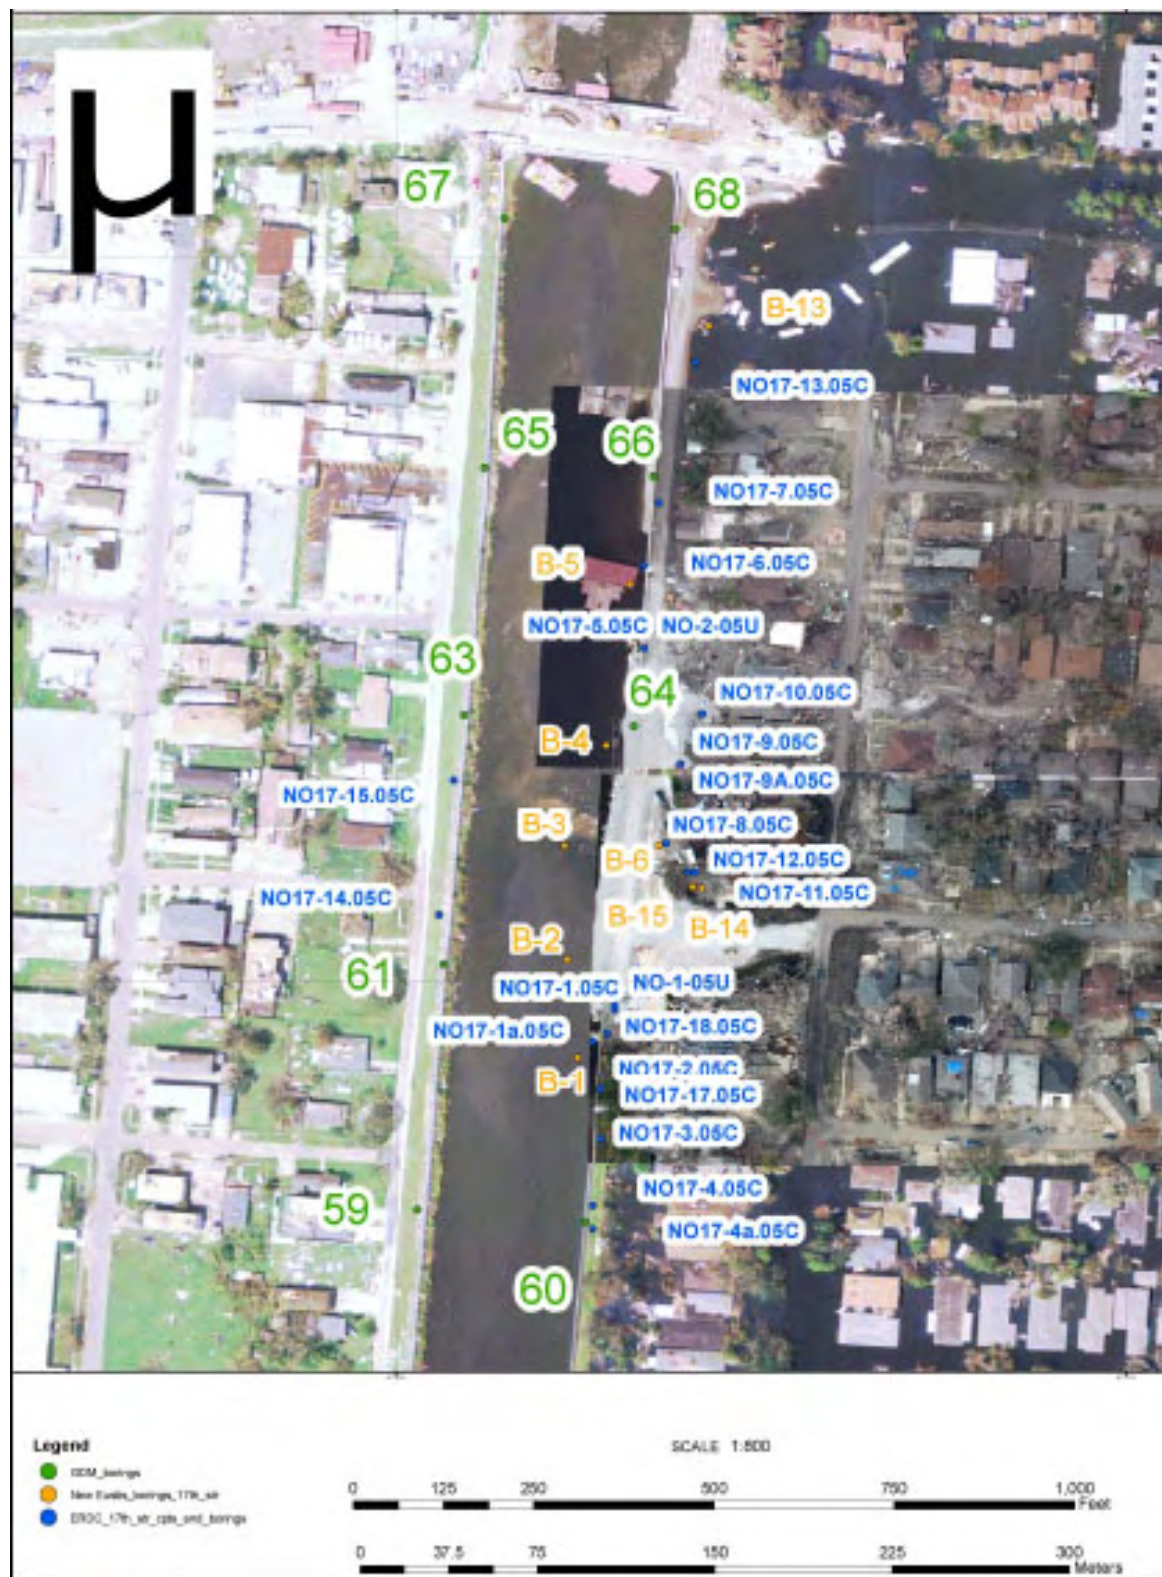
Figure 8.24: Oblique aerial view of the breach at the 17th Street Canal.

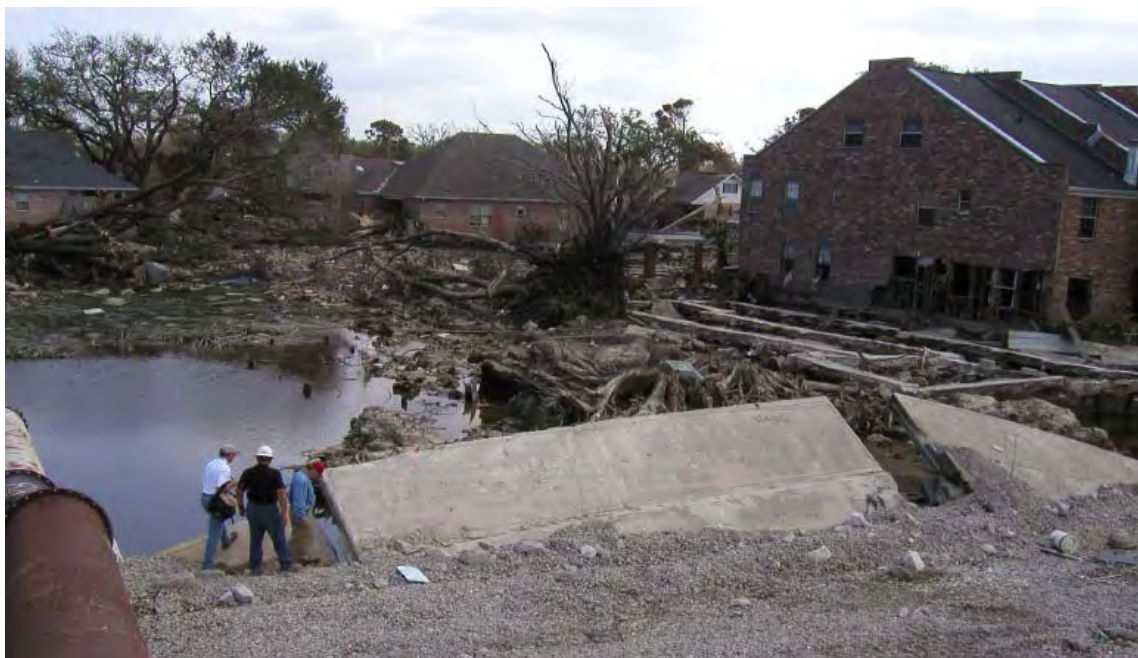
Figure 8.28: View of the 17th Street Canal breach site showing the tops of the I-wall sections that “pushed” (and followed) the displaced levee embankment section, and then toppled backwards towards the canal.

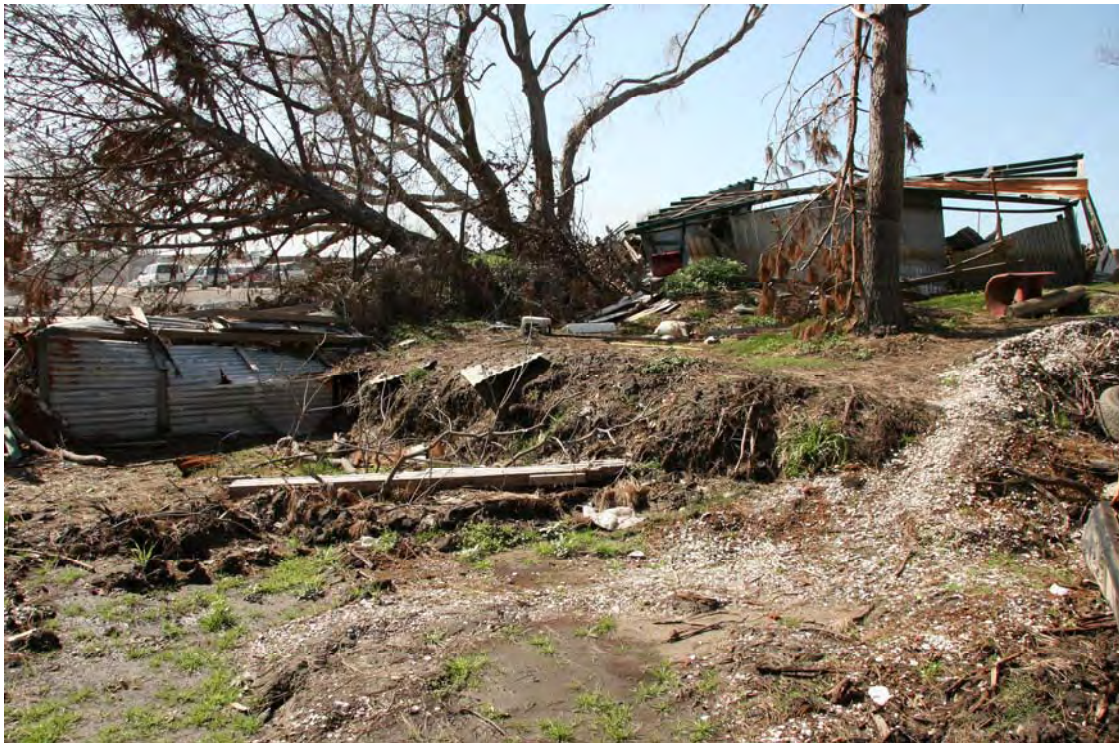
Figure 8.32: View of the exit of the upper failure surface (shear surface No.1 from Figure 8.27) at the inboard toe of the laterally translated embankment (toe scarp No. 1 in Figures 8.26 and 8.27).

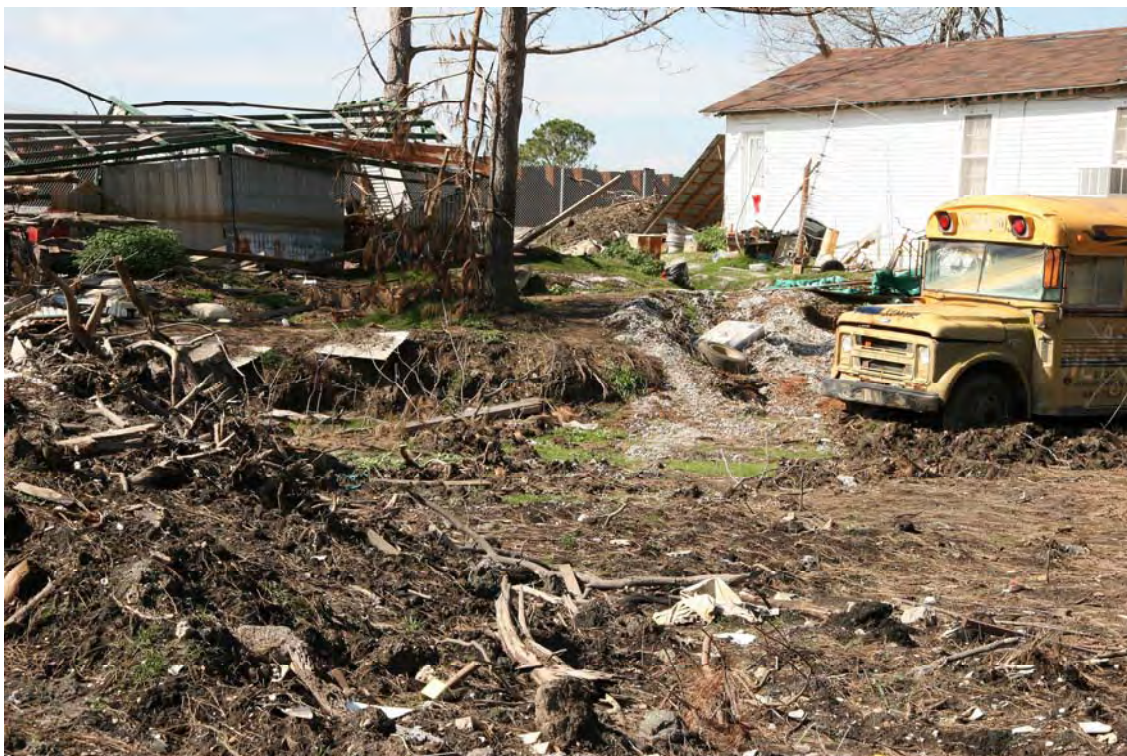
Figure 8.33: View of toe scarps No's. 2 and 3 at the inboard edge of the lateral translational failure at the 17th Street drainage canal.

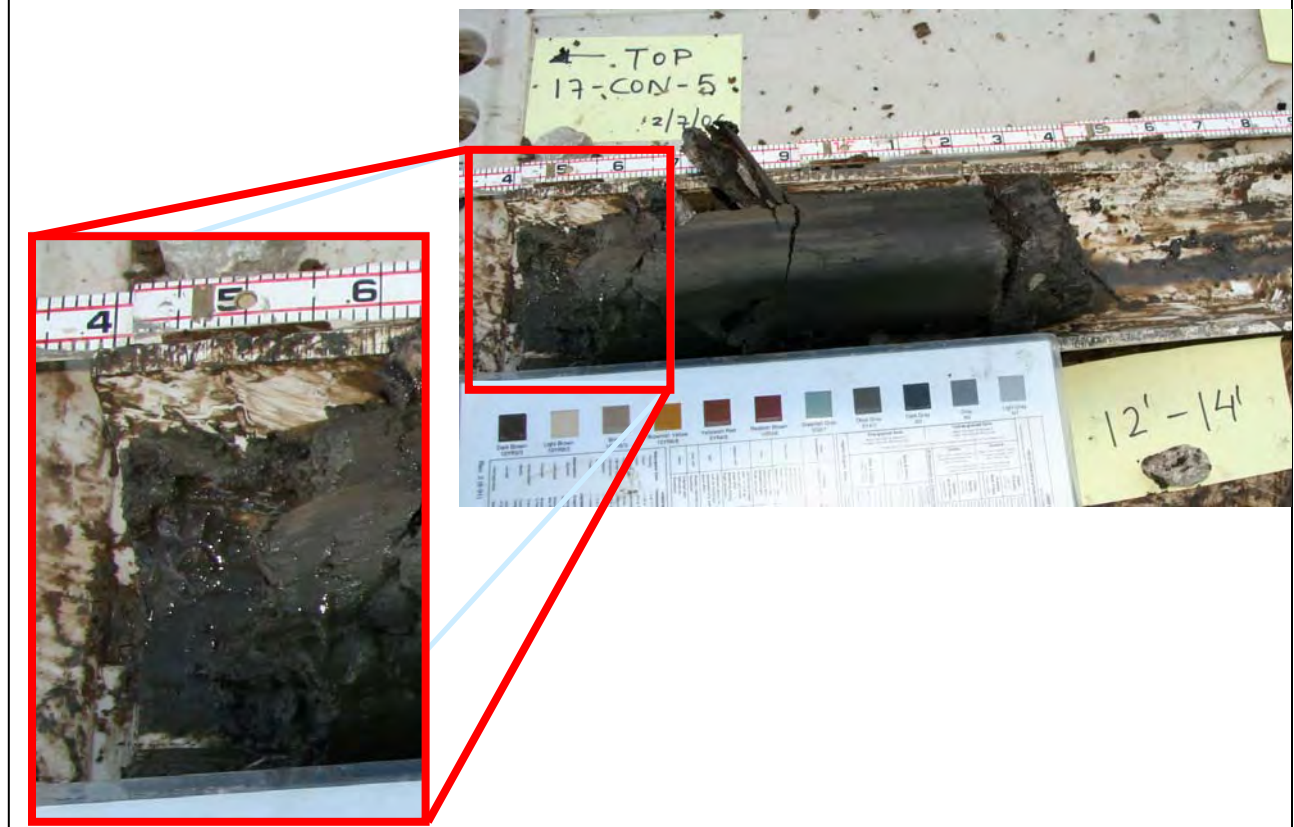
Figure 8.54 shows a photo of an “undisturbed” sample of this sensitive organic silty clay. The local clays have a gray, peanut butter-like appearance and consistency. They are not highly shiny, but rather semi-glossy, and their stiffness and texture are not unlike peanut butter. The sensitive organic clay, on the other hand, is dark and has a very shiny and translucent appearance; much like “jelly”, as shown in Figure 8.54. In Figure 8.54, hints of the organic detritus that closely overlies and masks access to this thin layer can also be seen.

Figure 8.54: Photo of an “undisturbed” sample of the sensitive organic silty clay.

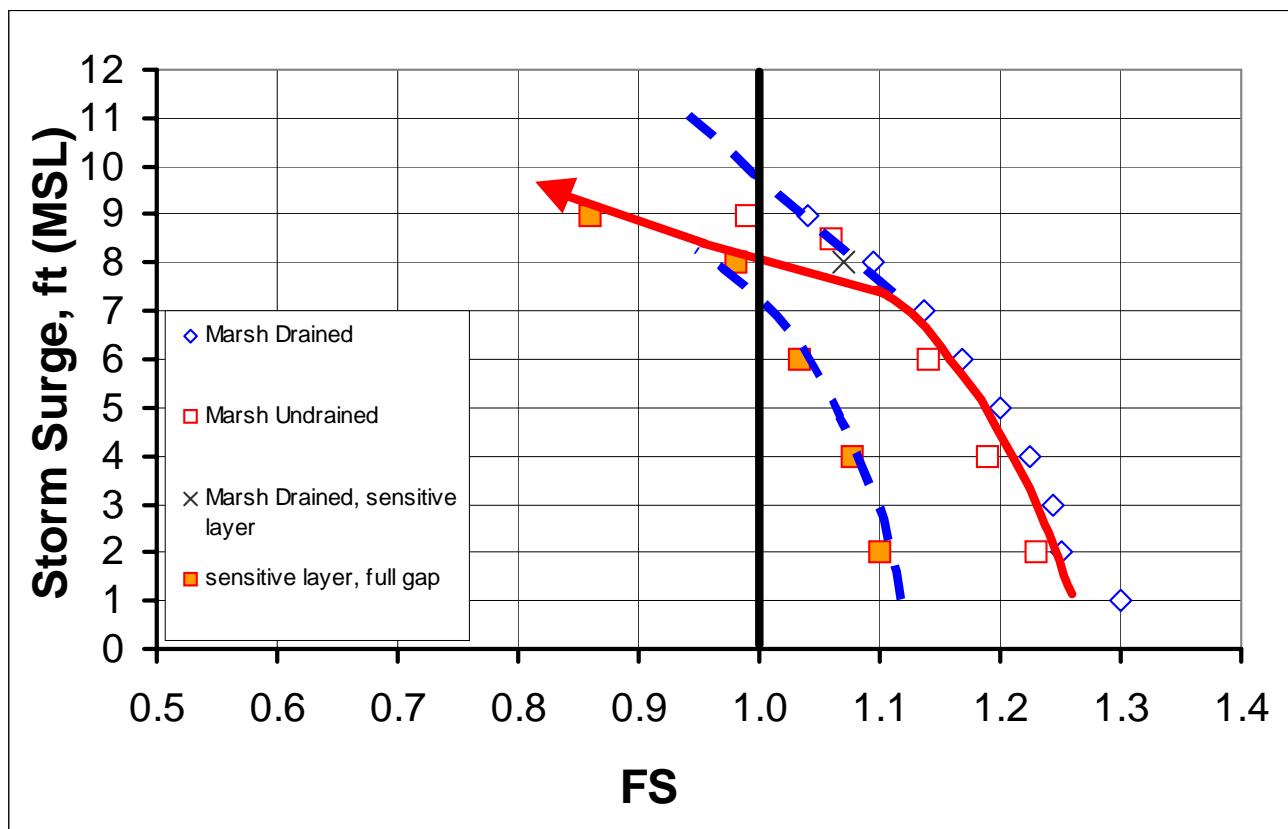
Figure 8.62: Calculated Factors of Safety for three modes based on PLAXIS analyses of the 7th Street Canal breach section for various canal water elevations; showing the best-estimated path to failure.

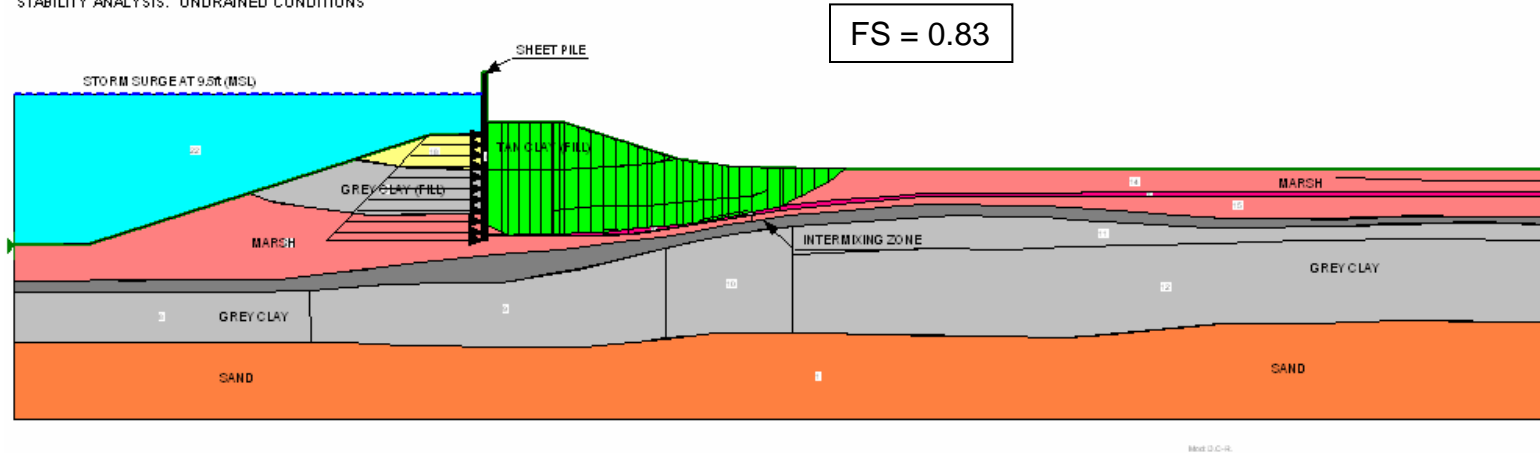
Figure 8.66: Stability analysis for actual observed failure mechanism at the 17th Street Canal breach section, with storm surge at Elev. + 9.5 feet (MSL) and with fully developed crack at the outboard side of the sheetpile/floodwall.

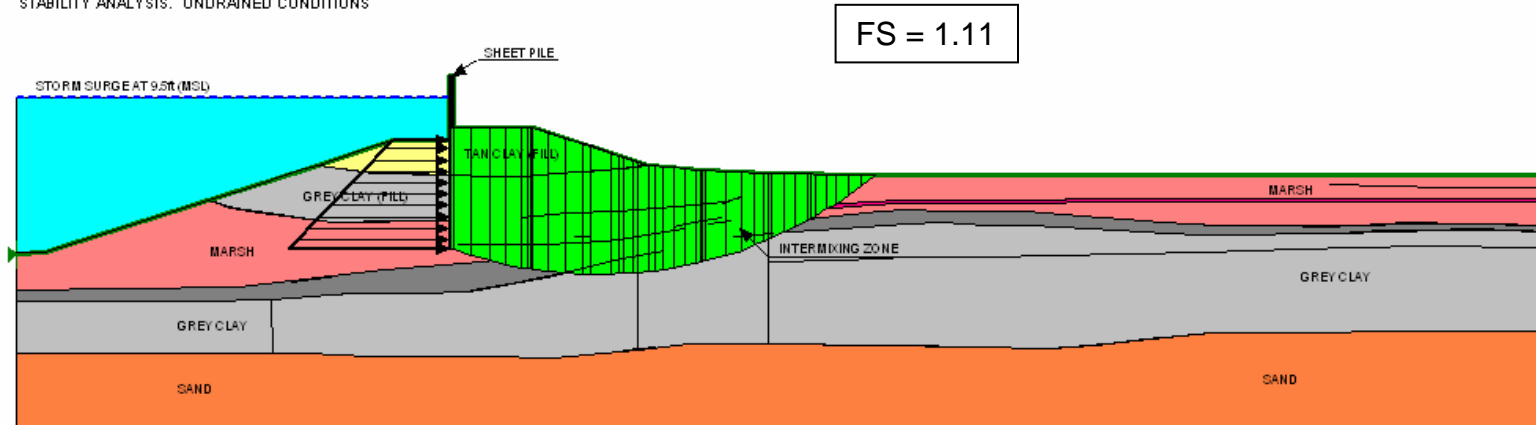
Figure 8.67: Stability analysis for shear failure through the deeper soft gray clays (CH) at the 17th Street Canal breach section, with storm surge at Elev. + 9.5 feet (MSL) and with fully developed crack at the outboard side of the sheetpile/floodwall.
